Development of Cost-Effective Timber Bridge Repair Techniques for Minnesota

Minnesota
Department of
Transportation

Brent Phares, Principal Investigator
Bridge Engineering Center and
National Center for Wood Transportation Structures
Iowa State University

Research Project
Final Report 2015-45A

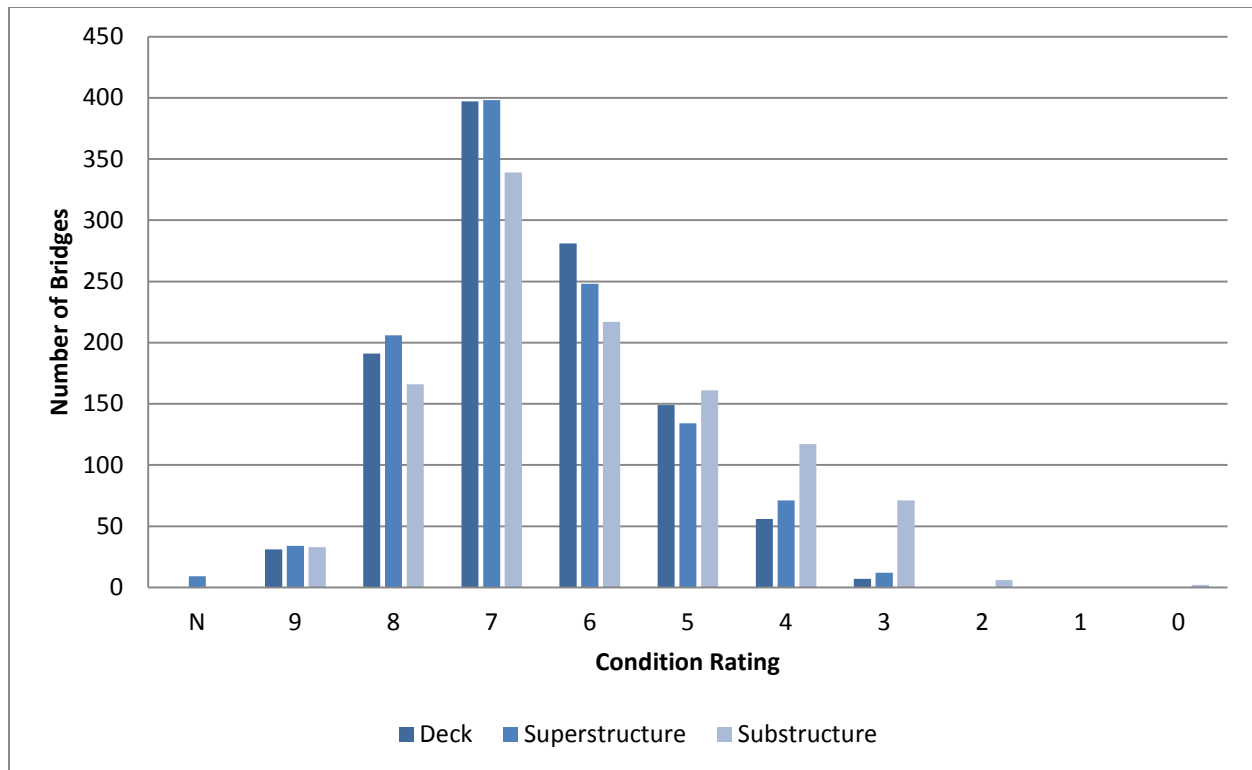
Figure 2-4 Condition ratings for slab and stringer bridges

The distribution of the condition ratings for deck, superstructure, and substructure among the slab and stringer bridges (1,476 total) is shown in Figure 2-4.

At first glance, it would appear that the bridges are in relatively good condition overall given that the distribution tends to peak around a condition rating of 7 or Good Condition. At closer look, however, note the number of bridges that are considered only in Fair (rating of 5) or worse condition. Figure 2-5 provides the cumulative distribution for each of the bridge elements that fall into or below any given condition rating.

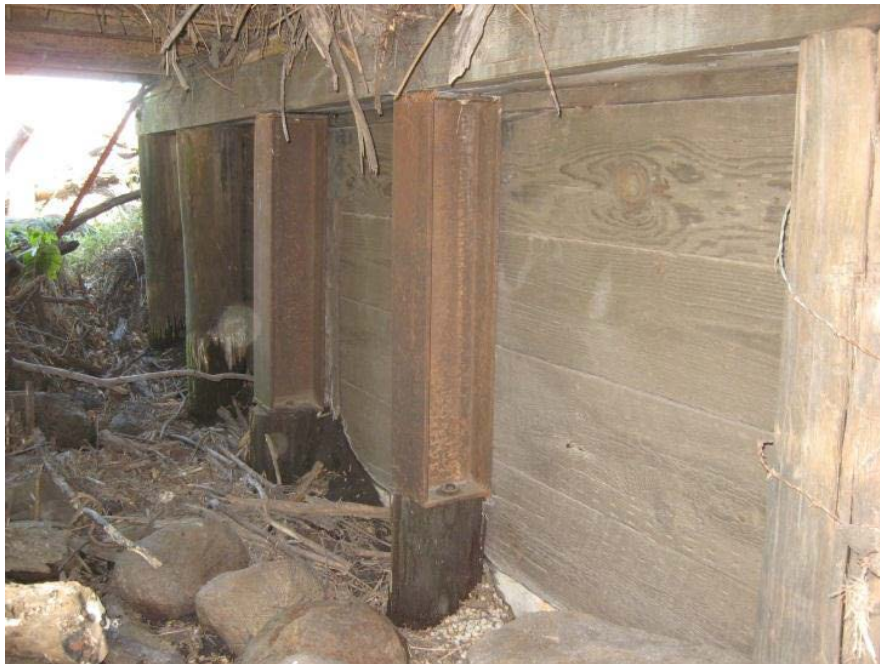
Figure 3-2 Posted piles using steel W shapes

A method of posting used in Iowa is shown in Figure 3-2 (Dahlberg et al. 2012).

Here, W shapes take the place of deteriorated portions of the pile. The method requires that the pile be cut below the area of deterioration at a sound, non-deteriorated location. It is at this location where a steel member is placed between the top of the remaining pile and the pile cap above and then lagged into place at both the top and bottom.

This posting method requires precision that may not always be achievable in the field. The steel must be fabricated to exactly fit the area between the remaining pile portion and pile cap. Moreover, full bearing between the pile and post or post and pile cap is rarely seen. One method to help alleviate the problem of non-fitting steel members was introduced by researchers at Iowa State University (Dahlberg et al. 2012). The method created the ability to vertically adjust the steel member to fit in a desired location using leveling nuts and a threaded rod, which are attached to angles that are lagged to the pile (see Figure 3-3).

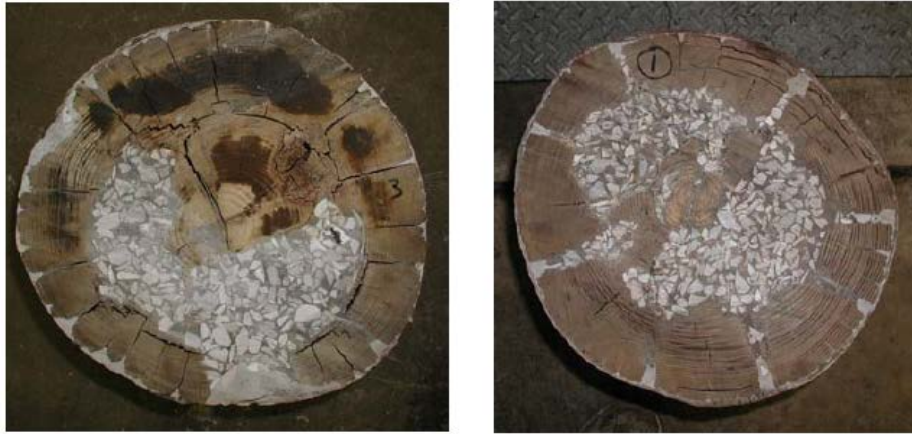
Figure 3-17 Cross-sections of epoxy- and aggregate-repaired piles

A method of repairing piles with aggregate and epoxy was developed and evaluated in Oklahoma (Emerson 2004). As is the case in many states, piles in Oklahoma experience significant fungal deterioration, which often results in only the exterior shell of the original pile remaining. Significantly decayed portions of the pile are removed while the remaining portions are re-treated to prevent future fungal decay. Epoxy and aggregate are then used to replace the decayed core, after which the pile is wrapped with fiber reinforcement for confinement of the wood/epoxy/aggregate core. It was found that without the confinement, the epoxy/aggregate mix separated from the wood. The compression strength of all specimens repaired in this manner was found to exceed that of the American Wood Council *National Design Specification (NDS) for Wood Construction* (1997 edition) design values and average compression strengths published in

the Forest Products Laboratory's *Wood Handbook—Wood as an Engineering Material* (1987 version) for wood species typically used for timber piles. Cross-sectional views of repaired piles are shown in Figure 3-17.

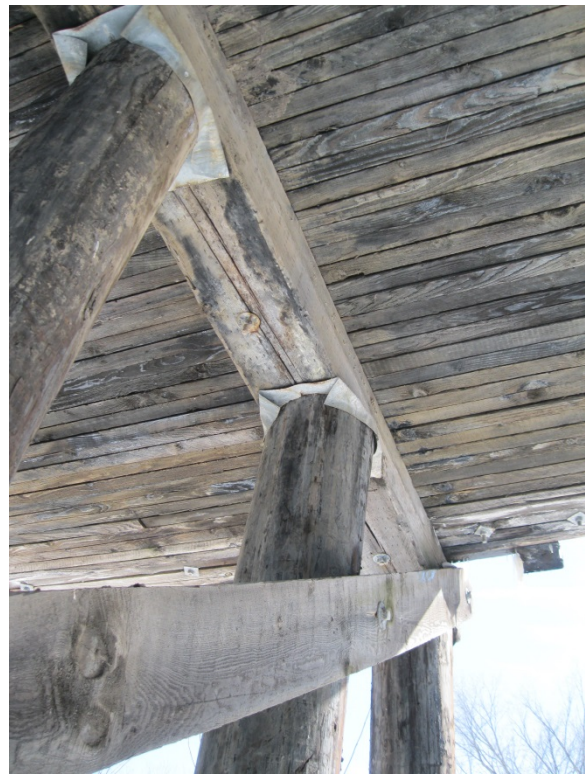
Figure 5-1 Timber substructure deterioration in Aitkin County, Minnesota

The ages of the timber bridges within the inventory of Aitkin County range from 7 to almost 60 years. Many of these bridges were constructed in the 1970s and 1980s and are typically spike-laminated slab-span construction. Frequently, the substructure elements and, more specifically, the timber piling at these bridges is what controls the overall condition state (see Figure 5-1).

a) Large check in pile at waterline

b) Large checks in pile cap

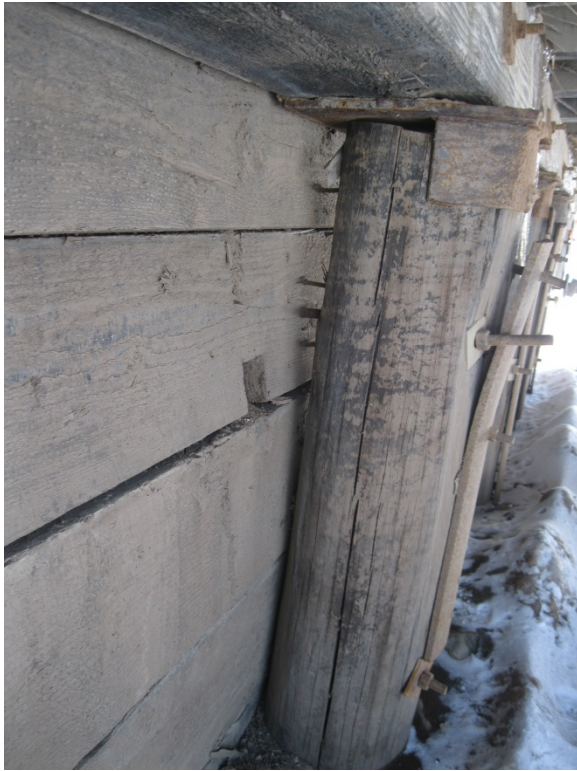
a) Pile rotation

The issues that the county is seeing that are common to timber bridges most often include deterioration and movement of substructure elements. One issue that is seen frequently is pile cap and pile rotation, especially at abutment locations. Although the cause is not completely known and is most likely a combination of several factors (backfill materials, freeze/thaw cycles, etc.), the effects are bulging backwalls, rotating piles, and subsequent separation of the piles and pile caps (see Figure 5-2a).

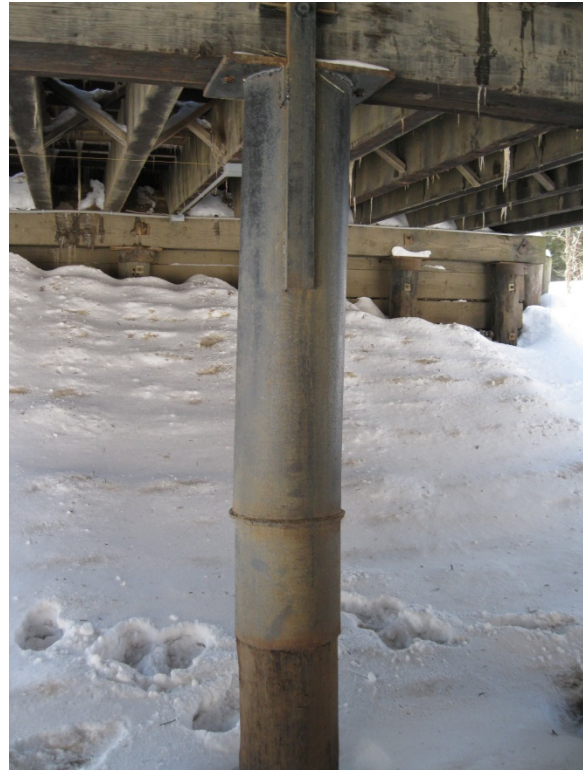
b) Steel replacement of timber pile

Because bearing is lost between the piles and pile caps, shims are required to reestablish a positive connection. Furthermore, section loss in piles and pile caps is of concern at many locations. At times, piles have been repaired by removing a portion of the pile and replacing with a steel member (see Figure 5-2b). These repairs appear to be effective, yet not intended for a long-term repair (as in intended for a short-term repair until full removal of the bridge or a more extensive repair is completed.)

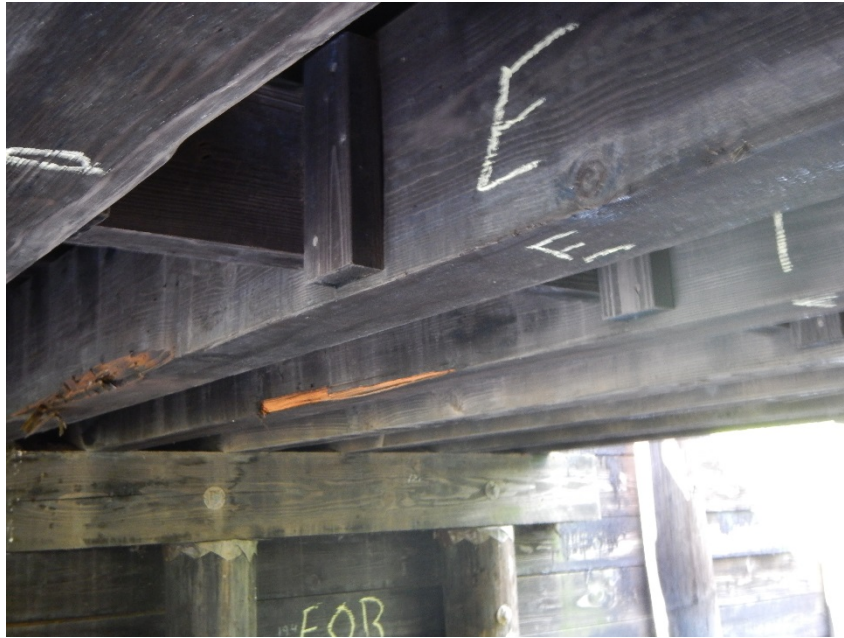
Figure 6-5 Stringer damaged by debris strike

Several reasons, including overloading, debris strikes (see Figure 6-5), and insect infestation cause deterioration of timber superstructures.

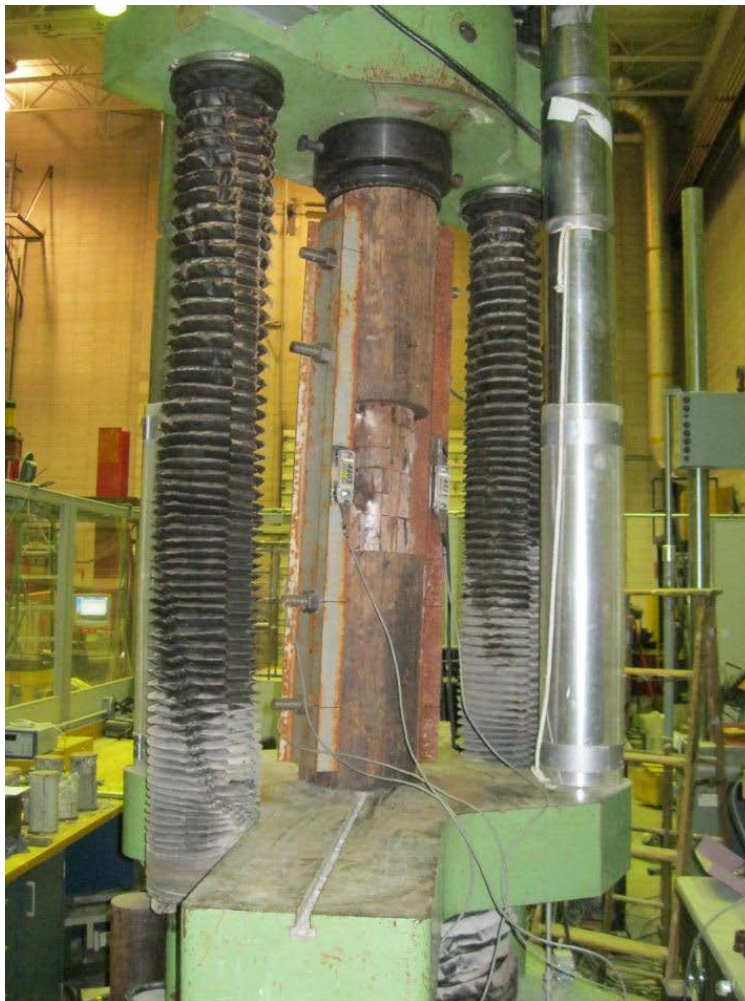
Figure 7-3 Sistered pile with channels and through bolts

Where a portion of the timber member is so deteriorated that it must be replaced, a splice can be constructed using similar concepts to the scabbing or sistering methods. The splice joints, like deteriorated portions, must be spanned to sound material where the scab or sister can be properly attached. Figure 7-3 shows an example of a sistered pile.
